# AYDO™ FLAME SAFE TRIPLE ACTION PROTECTOR

STOP FIRE  
STOP WOOD INSECTS  
PRESERVES WOOD

AYDO UNLIMITED CV

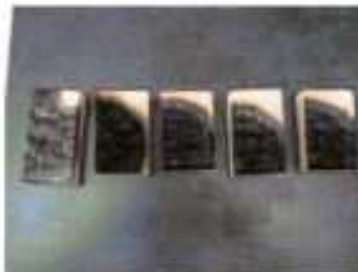
We observed that after 1 minute in front of the flame, the non-treated sample became grey-white. Charcoal and ashes have been formed. 3 to 4 mm of the wood is transformed in charcoal.

The treated samples (with the concentrated product as well as with the diluted product) became black; Charcoal is formed but no ashes. Only 2-3 mm of the wood is transformed in charcoal. It depended on the dilutions used.

Left: not treated; right: treated (pure and 3 dilutions)

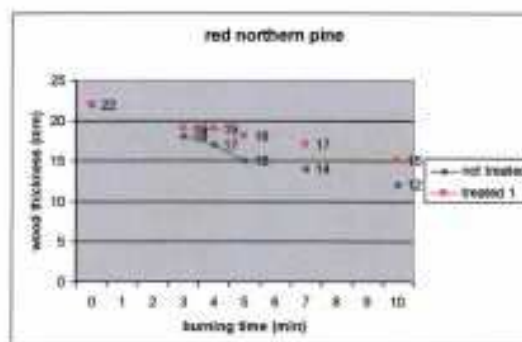
We saw that the wood of the non-treated sample is consumed faster by the flame, resulting in a decreasing thickness of the wood. Originally the samples were 22 mm thick.

After 3 minutes, 18 mm thickness is left on the non-treated wood and 19 mm on the treated one;

After 10 minutes, 12 mm left on the non-treated and 15 mm on the treated.

These values are considering the sample treated with the concentrated product.

The Graphic 1 below shows an overview of the results.

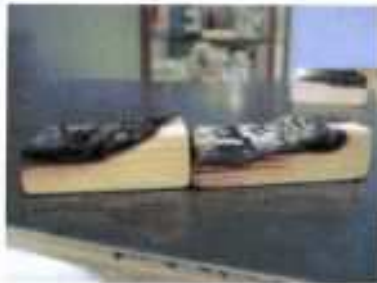
after 4 minutes in the flame  
left: treated; right: not treated

After 5 minutes, the non-treated wood started to lose its form and structure, while the treated sample was much more intact and keeping its form until the 10<sup>th</sup> minute. Some ash has been formed, but much less than on the non-treated sample.

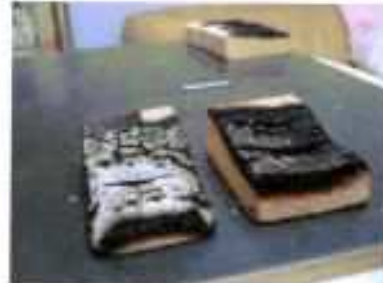
after 10 minutes  
left: not treated; right: treated

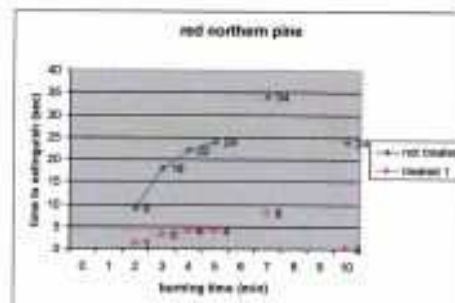
Graphic 2

Initially, both samples were extinguished in some seconds after being removed from the burner. But after a longer period of exposure to the flame source, it became clear that the non-treated sample kept burning during 24-34 seconds after being removed from the flame source, while the treated sample stopped burning after 4-8 seconds, and even after the 10<sup>th</sup> minute the treated sample stopped burning immediately as it was retired from the flame. This is good indication that the product is protecting the wood against fire; fire is not expanding and is easier to control.

Another aspect is the time that the samples remained burning when they were removed from the burner (see graphic 2).

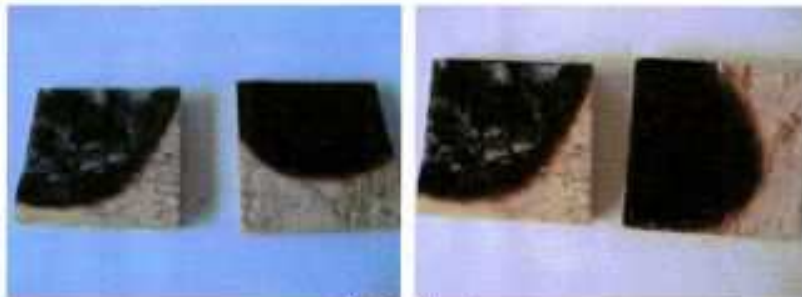
After 1 minute

The same tests have been done with the OSB III board. We observed that after 1 minute in the flame, the non-treated sample became grey-white. Charcoal and ashes have been formed. 2-3 mm of the wood were transformed in charcoal; after 3 minutes this charcoal measure 4 mm.

The treated samples (with the concentrated product as well as with the diluted product) became black. Charcoal was formed but no ashes. Also 2-3 mm of the wood was transformed in charcoal after 1 minute; and also 4 mm after 3 minutes.

Non-treated (left) - treated with concentrated (right)      non-treated (left) - treated with dilution 1/2 (right)

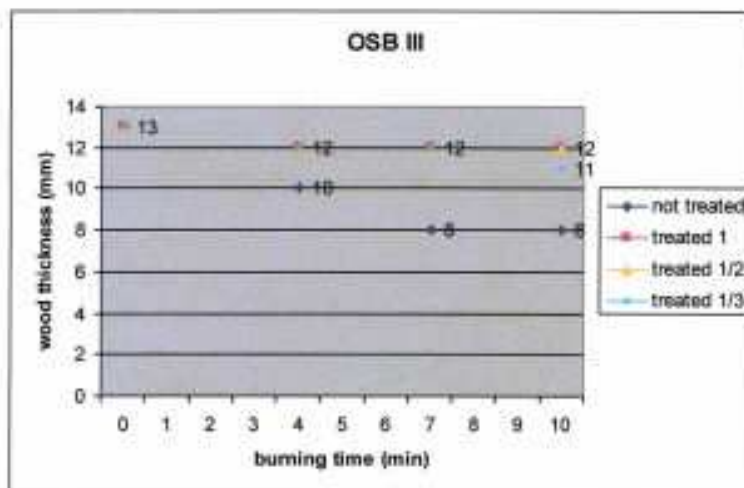
The thickness of the wood samples is measured from the third minute on. Graphic 3 above shows an overview of the results. The original measured thickness in all samples is 13 mm. After 10 minutes, 8 mm are left of the non-treated sample, compared with 11 to 12 mm of the treated samples.

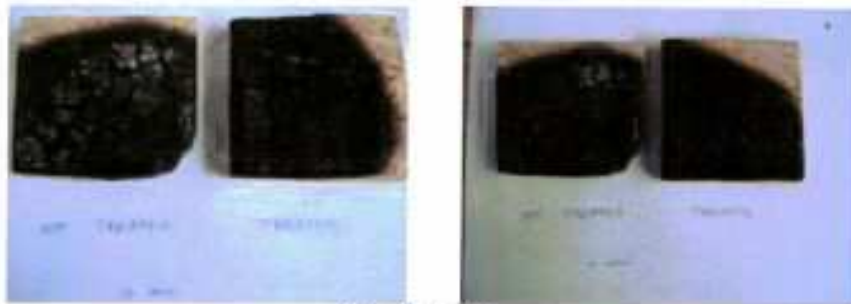
As you can see on the picture below, the structure of the board is much better preserved in the treated sample. The edges are less damaged, less material is burned and less ash is formed.

After 10 minutes  
 Non-treated - treated (concentrated)      non-treated - treated (diluted 1/2)

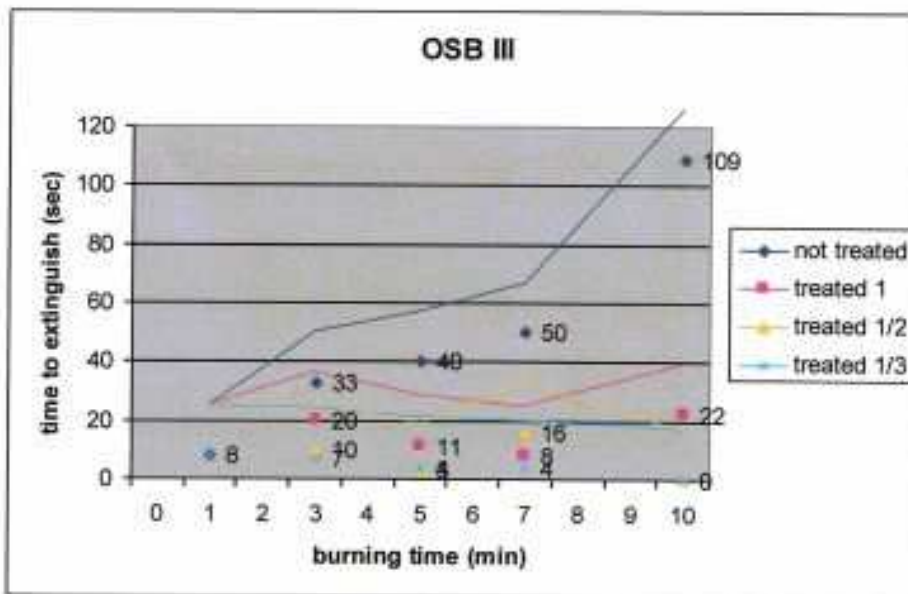
Graphic 4

The other aspect is the time the samples remained burning after they were removed from the burner (see graphic 4). Initially, both samples extinguished in some seconds. But after a longer time of exposure to the flame, it became clear that the non-treated sample after being removed from the burner kept burning (33-109 seconds); while the treated sample stopped burning at 4-20 seconds after being removed from the burner, and stopped immediately after in the case of 10<sup>th</sup> minutes of exposure (except for 2 samples – 22 and 11 seconds). This is a good indication that the product is protecting the wood against fire; the fire is not expanding and is easier to control.

An observation for the OSB is that the samples treated with the diluted product generally are extinguishing faster than the sample treated with the concentrated product. But this can also be the result of the heterogeneous characteristics of the OSB board. Based on the previous absorption tests it is also recommended to use the diluted product (1/2) for the OSB.

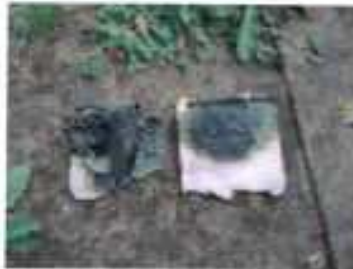
The treated sample was held in the flame for 10 seconds. The flame extinguished immediately, but it kept glowing for 2 minutes. Only the part that was directly in the flame became black and was superficially damaged.

*Left: not treated cardboard; right: treated with the Flame Safe*
